EVALUATION OF CODGELS CREEK MCB CAMP LEJEUNE NC  
11/1/1998  
CH2M HILL

# Evaluation of Cogdel's Creek

## Marine Corps Base Camp Lejeune, North Carolina

**November, 1998**

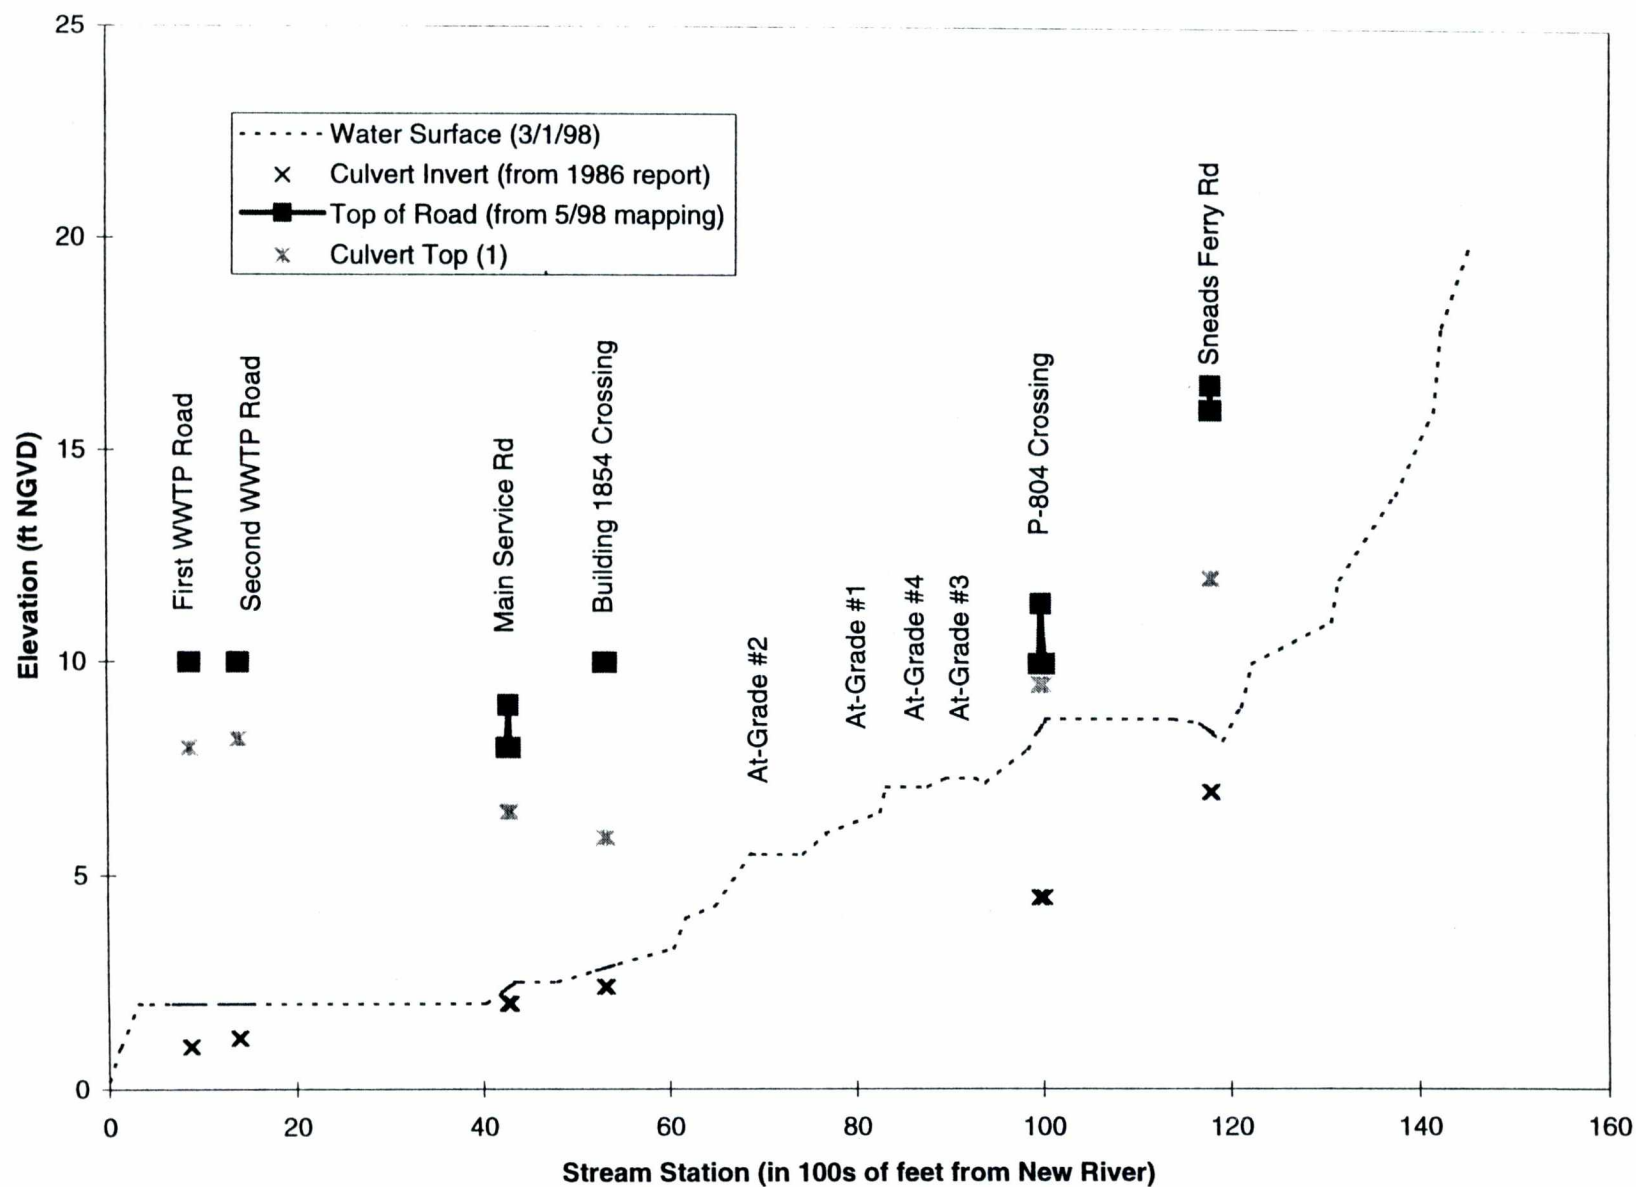
**Figure 6**  
**Cogdel's Creek Channel Profile**

The hydrology of Cogdel's Creek is controlled by a number of culvert and at-grade crossings that restrict flow (shown in Figure 7), which are discussed in detail below. During October 1997 field visits, sediment and/or vegetation significantly obstructed most culverts. Increased flow from developed areas does not appear to have caused streambank erosion problems, since sedimentation at culverts increases in-stream attenuation of flow.

Under design conditions (i.e. with no at-grade crossings and free-flowing culverts), the 1986 hydrologic model of the Cogdel's Creek watershed did not show any adverse flooding impacts from the culverts. This modeling was based on what were at the time future conditions, which are representative of existing conditions today. Attenuation by the uppermost culverts (above P804 and Sneads Ferry Road) reduced peak 10-year discharge rates by 50 percent. Based on 1992 Stormwater Discharge System maps provided by MCB Camp Lejeune, and field observations, it appears that some of the culverts may have been replaced and enlarged since then.

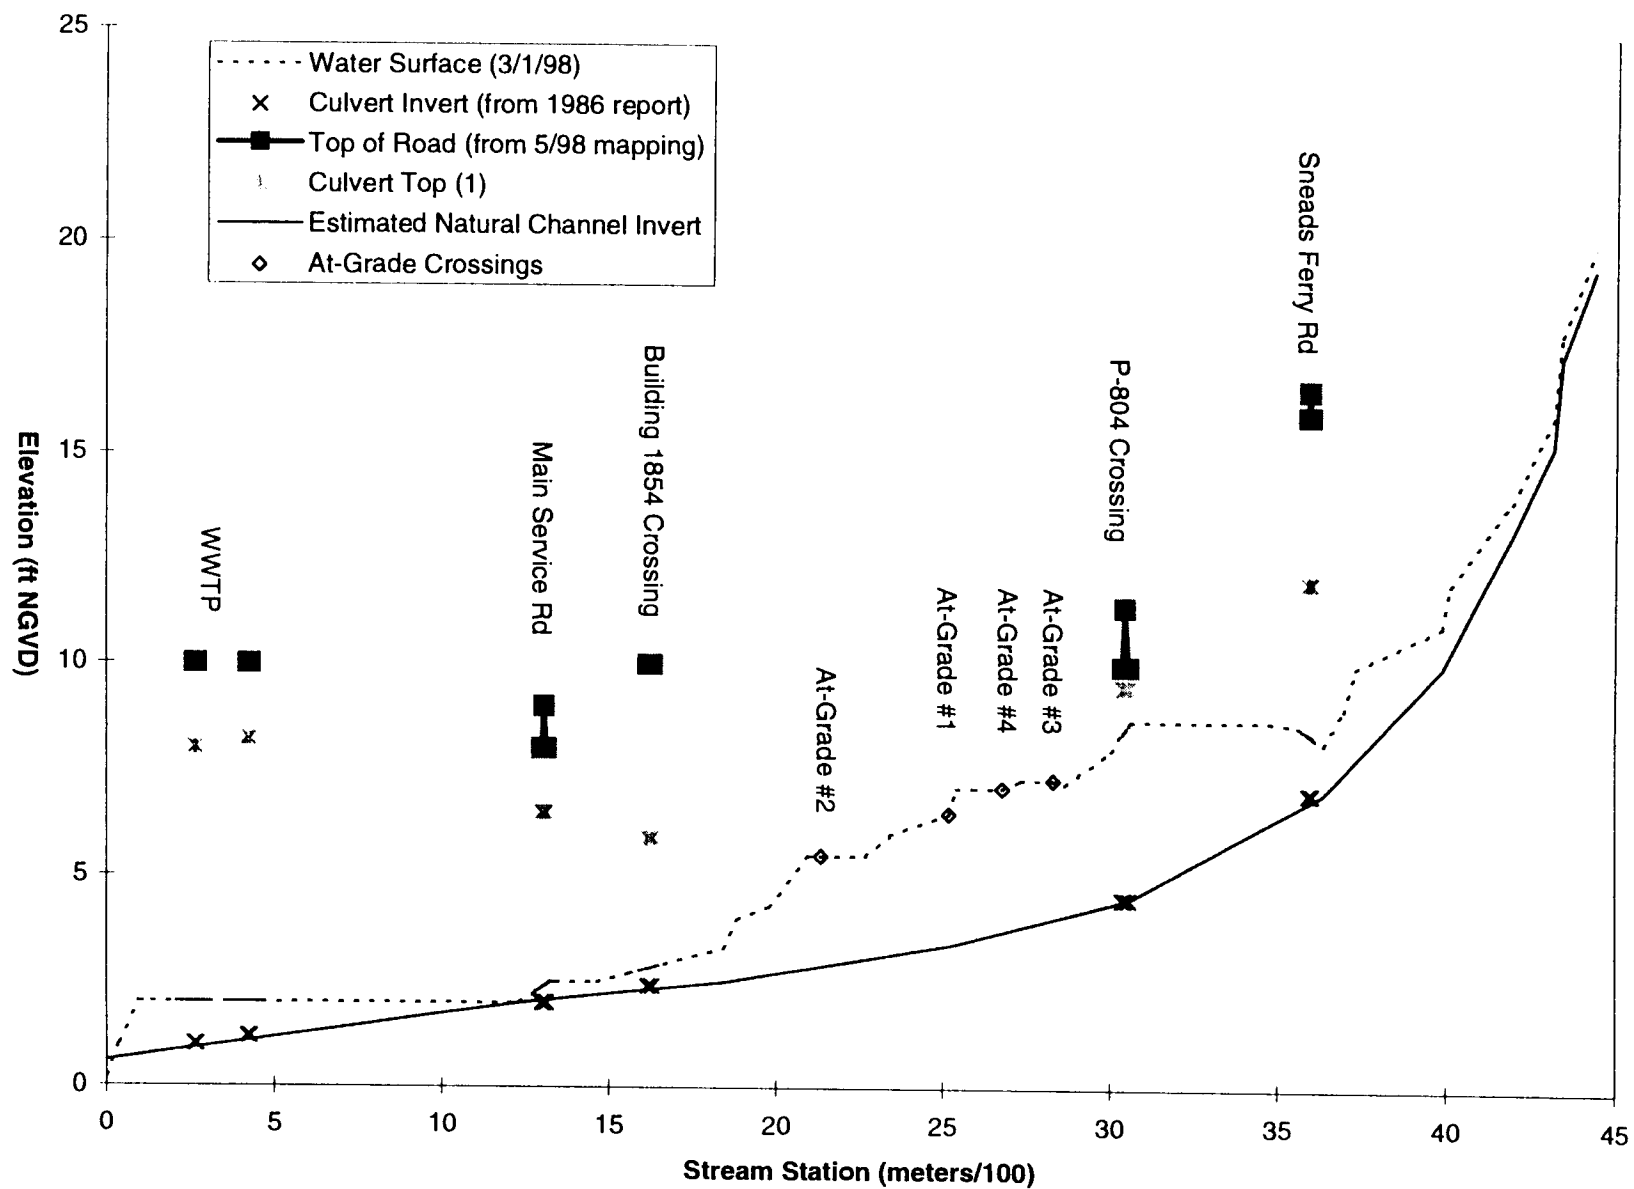
**Figure 9**  
**Cogdel's Creek Estimated Natural Profile**

Blockage of the culverts by sediment and other debris impacts the creek system in many ways. For example, at two of the crossings that were evaluated, culvert blockage appears to have contributed to excessive inundation of the upstream floodplain, killing most of the tree species that are adapted to less inundated conditions. Most of the dead and stressed trees and saplings at these crossings are not toppled which suggests that the condition stems from the high water levels and not from past severe storm event and wind damage.

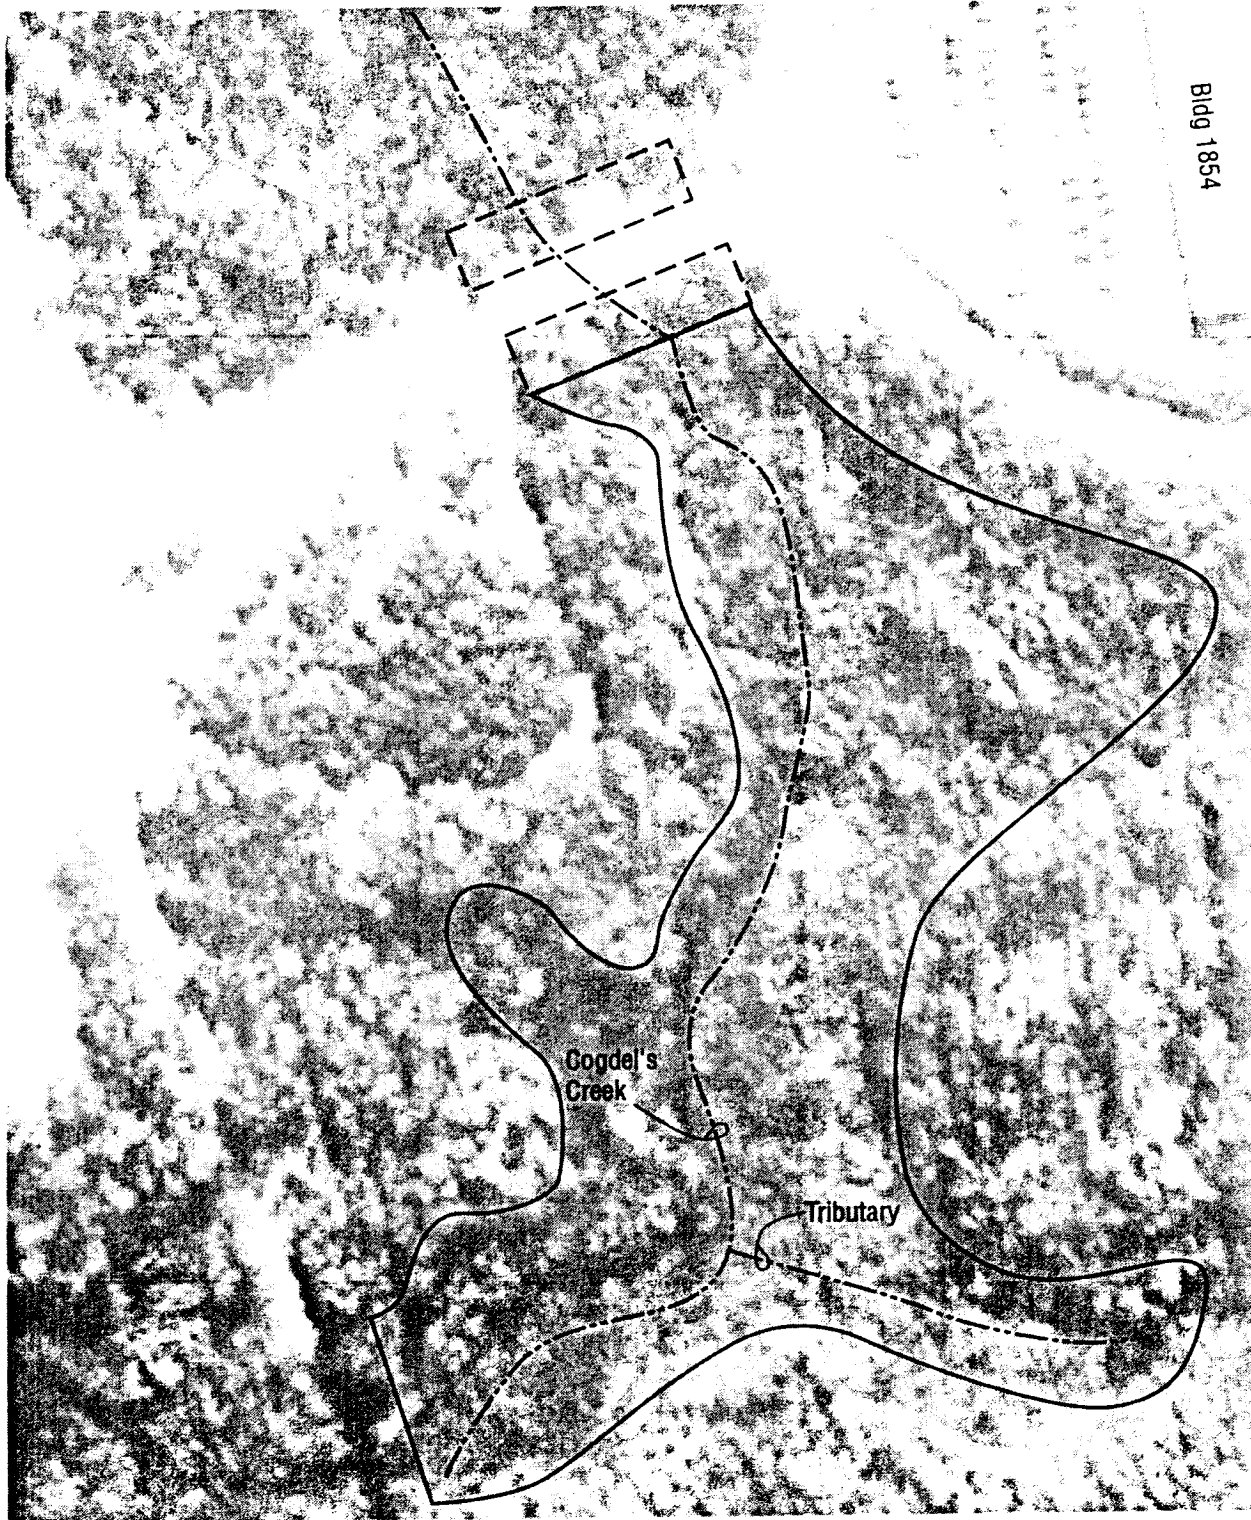
Figure 22  
**Site 10: Building 1854**  
**Culvert Crossing**  
 Cogdel's Creek

Crossing Location	Culvert Features <sup>1</sup>	Culvert Conditions	Erosion Features	Sedimentation/Blockage Problems
Bld 1854 and Duncun Rd	2 CMPs (48", 30") within concrete wingwall	Both good	No erosion	Sediment/debris dam 35' from pipes
	30" CMP with 48" splash block	Good	Severe erosion with overland flow	Sediment/debris dam 15' from pipe
Main Service Rd and creek	Three 54" RCPs	Fair	Some erosion directly above pipes  Sediment input on south side via trail and concrete plume	>50% blockage in both side pipes  Flow mainly through middle pipe (30% blockage)  Point bars on north side; no sediment dams
Behind Tank Maintenance Bld	Two 42" RCPs; concrete structures divert flow into pipes	One of the pipes is partially collapsed	Significant erosion off of tank trail directly into creek on both sides	No flow through collapsed pipe  Little flow through other one
Tank crossing near P804	Two 60" RCPs	Both pipes submerged; conditions unknown	No erosion; heavy vegetation on both sides	Both pipes appear to be blocked; no observable flow  Old beaver dam 30' upstream.

- Clear any debris and/or vegetation from culvert openings.
- As listed under Site 2 (tank trail), block at-grade crossings from traffic. Install traffic barriers at ORRV crossings and distribute information clarifying the areas ORRV use is allowed.
- Berm bare areas adjacent to creek to prevent erosion directly into the stream, allowing water to pond behind the berms.

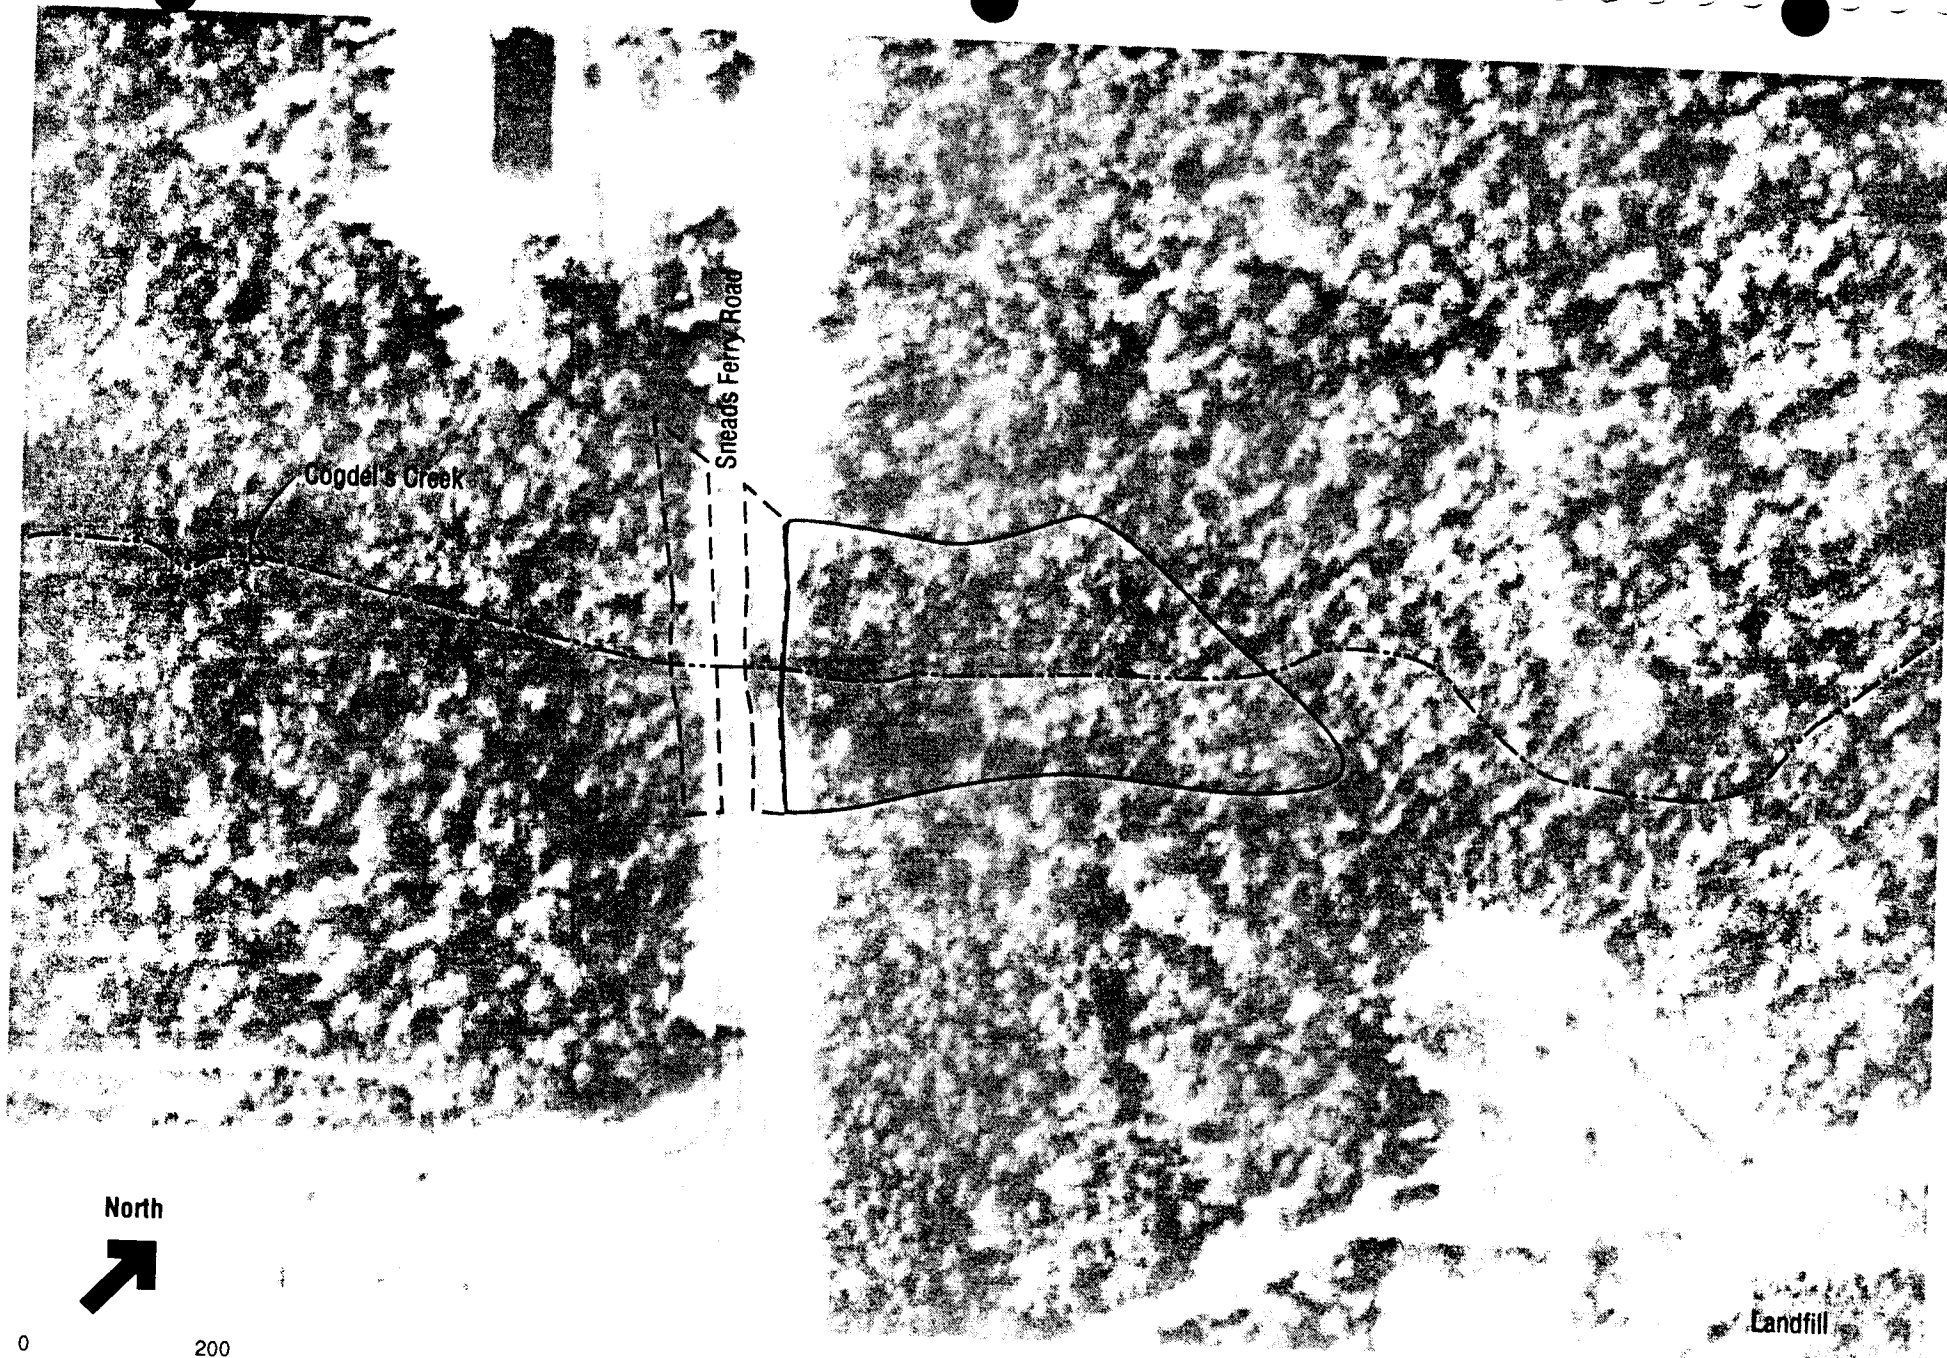
Figure 25  
**Site 13: Sneads Ferry Road Culvert Crossing**  
Cogdel's Creek  
**CH2MHILL**

Sneads Ferry Rd.	Two 60" CMPs	Both pipes submerged; conditions unknown	No visible erosion	No observable flow through pipes; dense vegetation at pipe openings blocking flow
Bld 914 across Sneads Ferry	30" RCP out of 9' concrete wall	Good	Slope erosion of intersecting ditches	4" of sediment in pipe
Bld 914	18" RCP out of 9' concrete wall	Good	Some erosion around wall; overland flow	No obvious blockage at wall; connecting upflow drain is blocked
